**DEPARTMENT OF TRANSPORTATION**

Quality Assurance and Source Inspection

Contract #: 04-0120F4Cty: SF/ALA Rte: 80 PM: 13.2/13.9File #: 69.28**WELDING INSPECTION REPORT****Resident Engineer:**Siegenthaler, Peter**Address:** 333 Burma Road**City:** Oakland, CA 94607**Report No:** WIR-020288**Date Inspected:** 06-Jan-2011**Project Name:** SAS Superstructure**OSM Arrival Time:** 700**Prime Contractor:** American Bridge/Fluor Enterprises, a JV**OSM Departure Time:** 1900**Contractor:** Zhenhua Port Machinery Company, Ltd (ZPMC), Changxing Island **Location:** Shanghai, China**CWI Name:** Mr.Zhu Zhong Hai.**CWI Present:** Yes No**Inspected CWI report:** Yes No N/A**Rod Oven in Use:** Yes No N/A**Electrode to specification:** Yes No N/A**Weld Procedures Followed:** Yes No N/A**Qualified Welders:** Yes No N/A**Verified Joint Fit-up:** Yes No N/A**Approved Drawings:** Yes No N/A**Approved WPS:** Yes No N/A**Delayed / Cancelled:** Yes No N/A**Bridge No:** 34-0006**Component:** Orthotropic Box Girder (OBG)**Summary of Items Observed:**

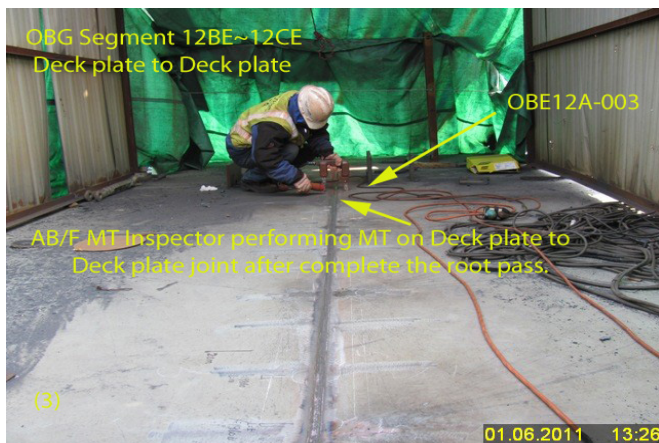
This QA Inspector observed AB/F Magnetic Particle Testing Inspector, performed MT on OBG Segment 12BE~12CE Deck plate to Deck plate joint after completed root pass. Joint identified as OBE12A-003. For more information see below attached picture number 3.
